## Visual inspection results and evaluation of Akhtala tailing safety based on tailing management facility safety methodology

K.S. Sahakyan✉, A.A. Sarukhanyan

*Visual inspection at Nahatak TMF.* TMF methodology was applied to the operated TMF of the Akhtala Ore Dressing Combine (Lori region, Armenia), for which all documentation was checked and thoroughly studied.

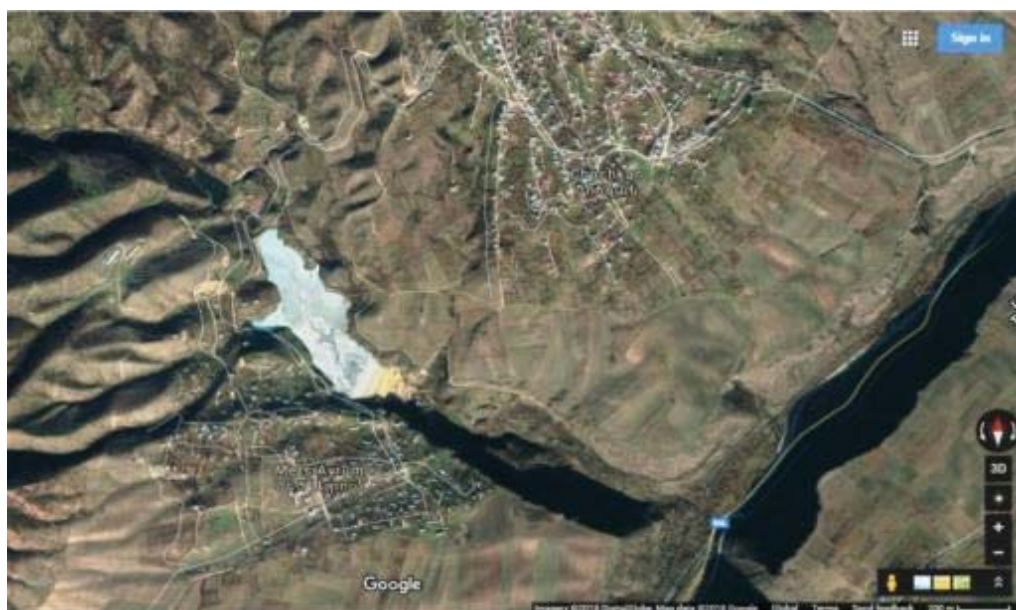
**Fig. 1.** Location/view of the Nahatak TMF of the Akhtala ore dressing combine

A visual inspection showed that the tailing dump was more than 80% full, and the surface of the lake was approximately 8 ha.

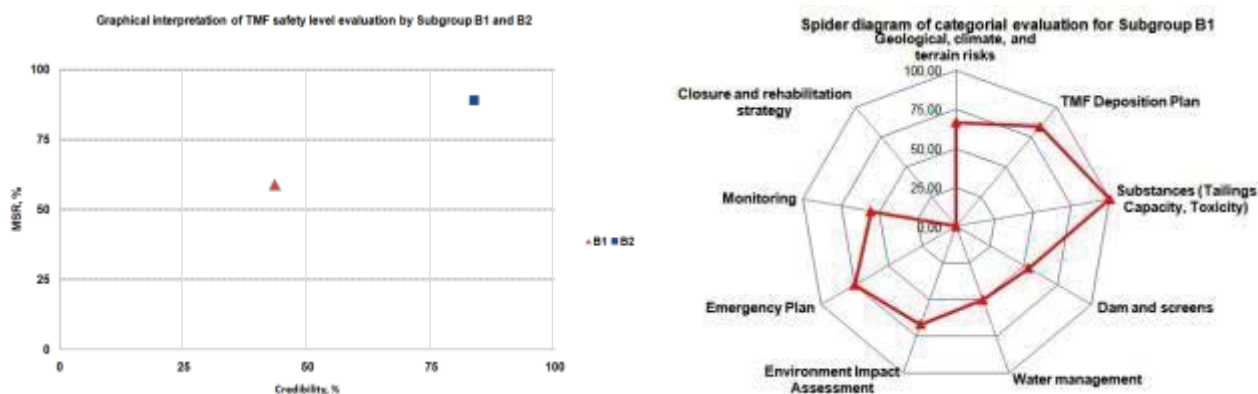
| Group of participants<br>Группа участников | Checklist questions<br>Вопросы контрольного списка | Not applicable<br>Не применимо | Yes<br>Да | Mostly yes<br>В основном да | Mostly no<br>В основном нет | No<br>Нет | Minimum set of requirement (MSR)<br>Минимальный набор требований (МНТ) | Credibility<br>Достоверность |
|--|--|---|---|---|---|---|--|---|
| Main dam<br>Основная дамба | Subgroup B1<br>Подгруппа B1 | 14.3 | 22.9 | 31.4 | 17.1 | 14.3 | 59.1 | 43.3 |
| | Subgroup B2<br>Подгруппа B2 | 5.4 | 75.2 | 12 | 3.5 | 3.9 | 89 | 83.6 |
| | Group B (B1+B2)<br>Группа B (B1+B2) | 6.5 | 68.9 | 14.3 | 5.1 | 5.1 | 74 | 63.5 |

**Fig. 2.** Safety evaluation results for the main dam: a) overall evaluation; b) categorial evaluation for visual check

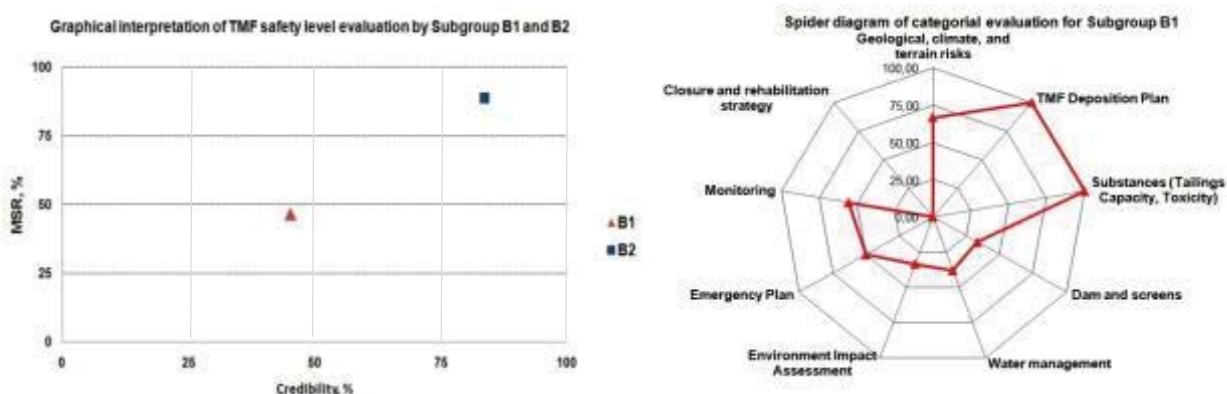
| Group of participants<br>Группа участников | Checklist questions<br>Вопросы контрольного списка | Not applicable<br>Не применимо | Yes<br>Да | Mostly yes<br>В основном да | Mostly no<br>В основном нет | No<br>Нет | Minimum set of requirement (MSR)<br>Минимальный набор требований (МНТ) | Credibility<br>Достоверность |
|--|--|---|---|---|---|---|--|---|
| Drainage canal<br>Дренажный канал | Subgroup B1<br>Подгруппа B1 | 11.4 | 17.1 | 28.6 | 20 | 22.9 | 47.1 | 45.2 |
| | Subgroup B2<br>Подгруппа B2 | 5.4 | 75.2 | 12 | 3.5 | 3.9 | 89 | 83.6 |
| | Group B (B1+B2)<br>Группа B (B1+B2) | 6.1 | 68.3 | 14 | 5.5 | 6.1 | 68.1 | 64.4 |

**Fig. 3.** Safety evaluation results for the drainage canal: a) overall evaluation; b) categorial evaluation for visual check

- increase through put of TMF drainage facilities (cleanse it of vegetation; remove plants in the diversion channel and check its integrity);
- permanently monitor drainage water streams using automatic analyzers;
- assess the possible dam failures and dam stability;
- equip the TMF with facilities preventing unauthorized access;
- develop a risk management strategy based on the assessment of risks posed by the abandoned TMF.

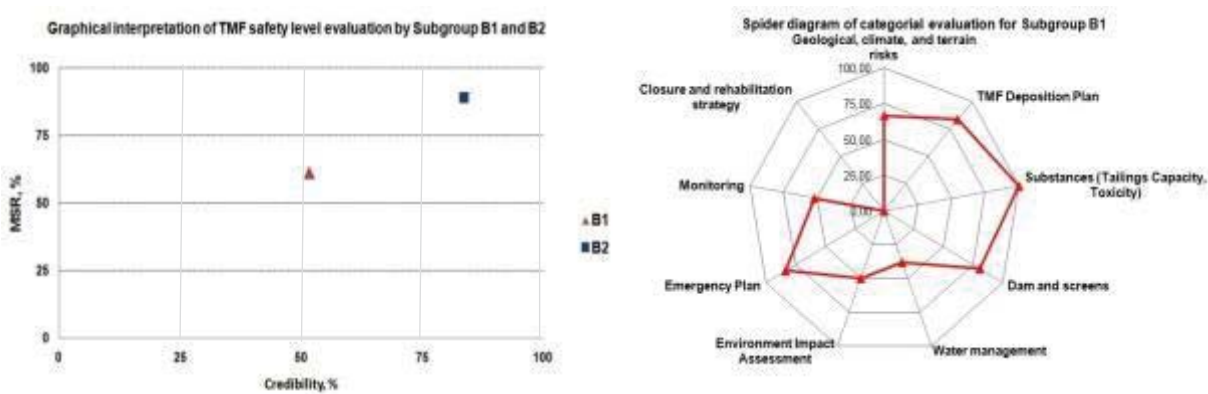
| Group of participants<br>Группа участников | Checklist questions<br>Вопросы контрольного списка | Not applicable<br>Не применимо | Yes<br>Да | Mostly yes<br>В основном да | Mostly no<br>В основном нет | No<br>Нет | Minimum set of requirement (MSR)<br>Минимальный набор требований (МНТ) | Credibility<br>Достоверность |
|--|--|---|---|---|---|---|--|---|
| Secondary dam<br>Вторичная дамба | Subgroup B1<br>Подгруппа B1 | 11.4 | 28.6 | 34.3 | 8.6 | 17.1 | 61.6 | 51.6 |
| | Subgroup B2<br>Подгруппа B2 | 5.4 | 75.2 | 12 | 3.5 | 3.9 | 89 | 83.6 |
| | Group B (B1+B2)<br>Группа B (B1+B2) | 6.1 | 69.6 | 14.7 | 4.1 | 5.5 | 75.3 | 67.6 |

**Fig. 4.** Safety evaluation results for the secondary dam: a) overall evaluation; b) categorial evaluation for visual check

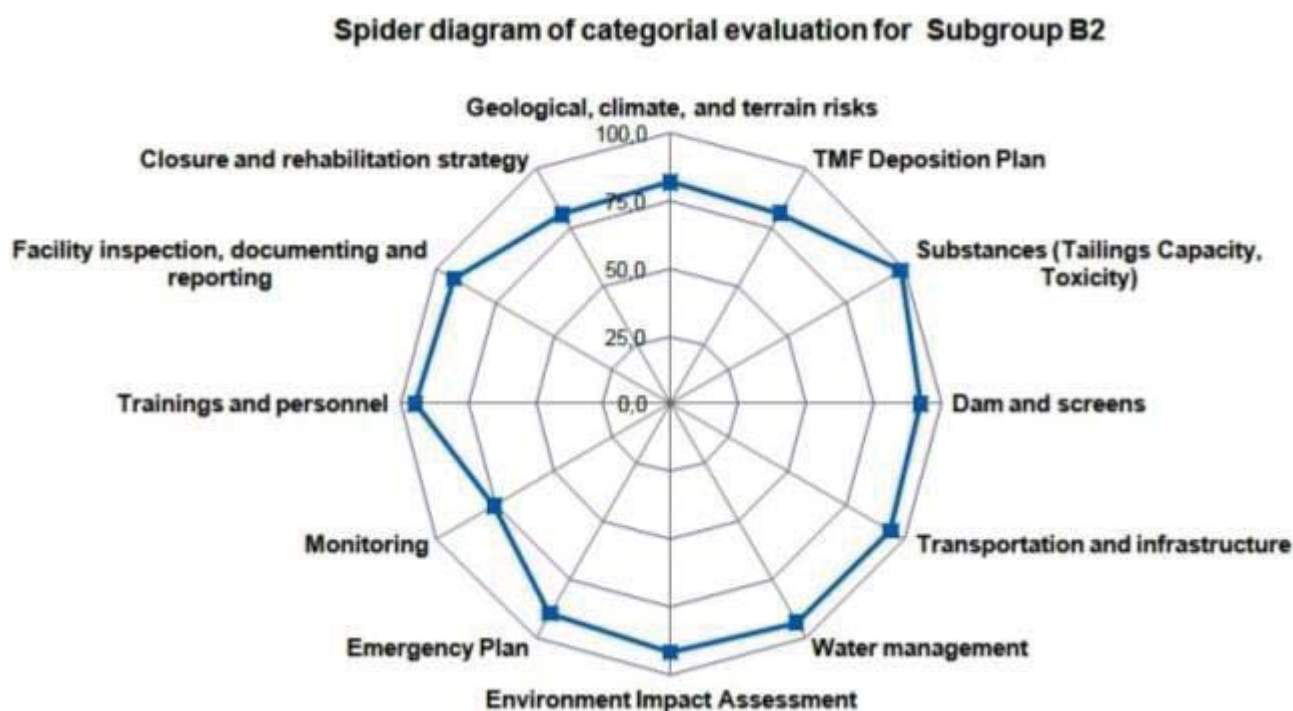
**Fig. 5.** Safety evaluation results obtained by document check
