## Testing of a Piled (Permeable) Breakwater Made of Composite Material for Coastal Protection. Part 1: Installation Conditions and Stability Assessment

The article discusses the results of an experiment (03 October 2021–30 April 2023) to test a “Grebenska” breakwater (breakwater of a through structure, or wave-breaking piled wall) made of composite material. The purpose of the study is to prove or disprove the hypothesis that the structures under study are sufficiently resistant to natural effects of the marine environment and can be considered as an alternative to existing coastal protection methods and means. The test breakwater in the form of five 12-meter modules, four of which were arranged in a line, was installed on the northern shore of the Sambia Peninsula (Baltic Sea, Kaliningrad Oblast<sup>1</sup>). The state of the breakwater was registered by various methods, including underwater and aerial photography. The results of the study showed that the installation of modules on the unprepared bottom caused their shear and tilt as a result of wave action. In order to improve the resistance of the “Grebenska” breakwater to such impact, it is necessary to prepare the bottom by

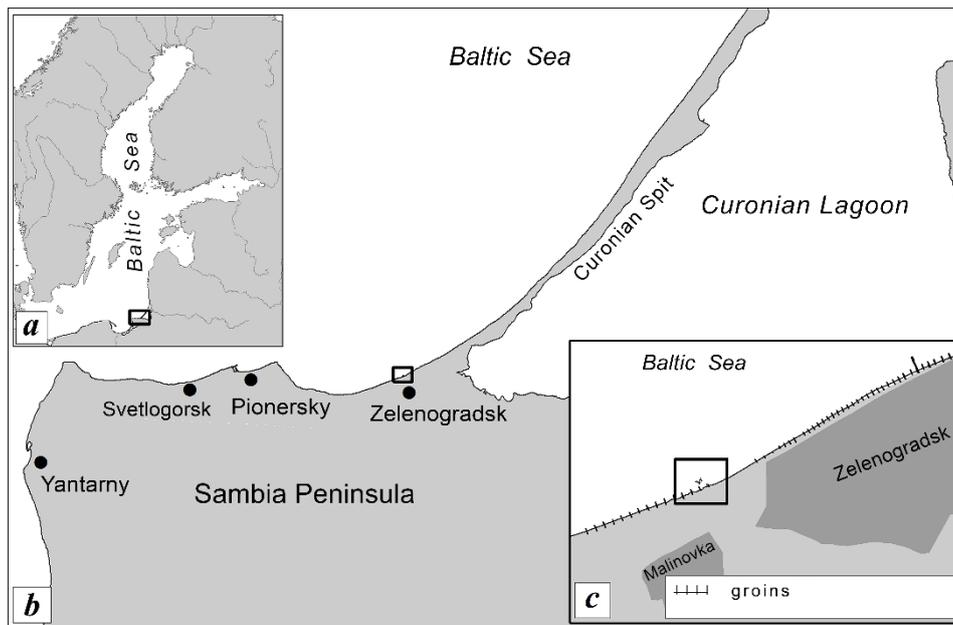
Fig. 1. Place of the experiment: *a* – the Baltic Sea; *b* – the northern shore of the Sambia Peninsula, Kaliningrad Oblast'; *c* – a section of the shore adjacent from the west to the Zelenogradsk city beach. From left to right: old groins (dashes on the shore line), a breakwater in the sea (the breakwater and four old groins are highlighted by a rectangle), a group of new groins and a pier protruding into the sea

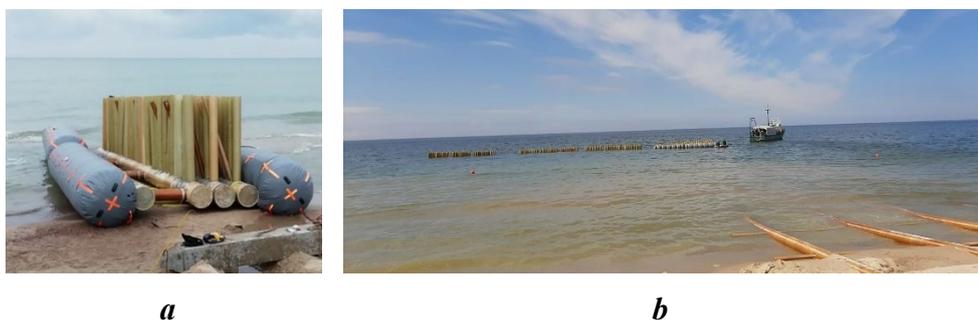
Fig. 2. The module (with pontoons) on the shore (*a*), a line of modules (*1–4*) and a number of installation slips in May 2021 (*b*)

The modules were launched and transported to the sea using inflatable pontoons (Fig. 2, *a, b*) with a carrying capacity of 8 t (4 pieces per module). From the sea, the modules with pontoons were towed by the boat through 33 m long prefabricated slips (Fig. 2, *c*).

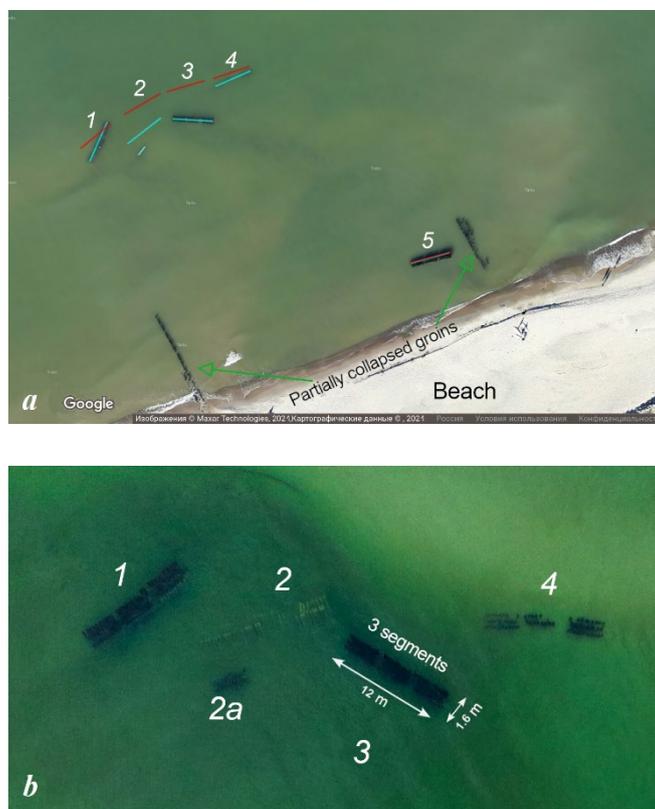
A series of heavy storms during the 2020–2021 winter period disrupted the linear arrangement of modules *1–4* (Fig. 3): three out of five modules were displaced or rotated. From the second year of the experiment, the disturbed linear array of modules acted as a disjointed set of modules and did not provide the expected wave-dampening effect.

Fig. 3. Initial and final location of the “Grebenska” breakwater modules: *a* – initial (red lines) and final (blue lines) location of the modules (Google Maps image, 2021. <https://www.google.ru/maps>); *b* – location of the “Grebenska” breakwater modules on 12 April 2023

The repeated photography of all modules was carried out from the UAV on 12 April 2023 (Fig. 3, *b*). It uncovered module 2, which was not visible in the UAV photography dated 07 September 2022 because it was under the sand layer of the underwater berm. The tops of the vertical piles rose 0.4–1.0 m above the bottom and tilted towards the sea. Module 2 appeared to be split into two parts. Probably, the splitting of the module into several parts occurred due to the violation of installation technology of the structure. The reason for this will be definitively determined when the module is dismantled. The most probable explanation is that the connecting cross pipes of the module grid base, which were not cast in concrete, fell onto an uneven part of the bottom under the layer of sand causing the module to break when the sand was eroded.

In Fig. 3, the dark colour of the piles is associated with algae fouling (except for module 2 (Fig. 3, *b*), which was entirely under sand); part 2*a*, separated from module 2, was not completely covered, so its piles were partially covered with algae.

only occur within the inter-groin pocket blocked by the structure. At this stage, based on the results of the experiment, the organisers admit that a mistake was made in the location of the structure: with its short length, it was too far from the shore. This experience will have to be taken into account when building similar structures in the future.

The modules are preferably orientated so that the additional horizontal pipe at the base is on the shore side, providing support against wave action and preventing overturning. In this installation, the modules were orientated the other way round.

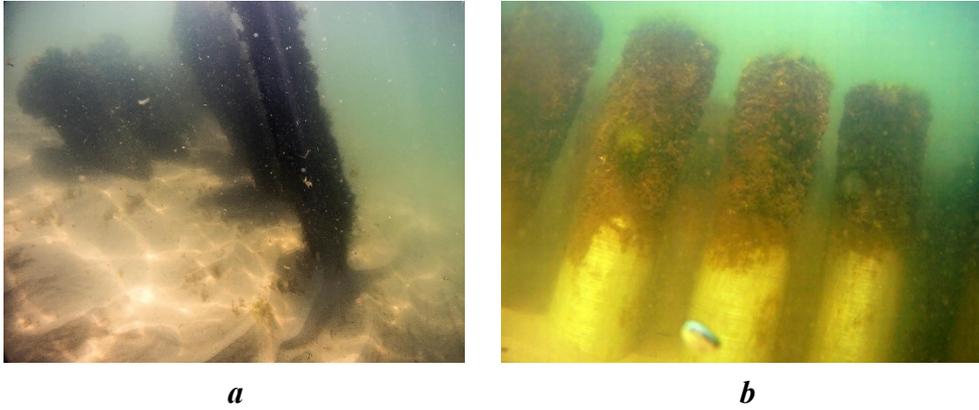
The most complete survey of the structure was carried out on 07 September 2022 (Figs. 3–5). Module *1* was 1.5 m above the ground, had not been destroyed or overturned and was almost completely covered by water, although it was 0.5 m above the water level when installed; the top 2/3 of the unsanded part of the piles were covered with filamentous algae. Segment *2a* of module *2* was 1 m above the ground,

tilted westwards towards the shore and was completely covered by water. The entire visible part of the piles was covered with algae. The depth at the location of module 3 was 1.2 m. It was not destroyed or overturned. Some of the piles were 0.1–0.3 m above the water. The piles were covered with algae along the entire length of the underwater section. Module 4 was up to 0.5 m above the bottom, tilting to the west and completely covered by water. The western part of the module was almost completely hidden by the sand, with only the upper eastern, unsanded part up to 1/3 of its height covered with algae. Fig. 3, *b* shows that the module split into two parts following the longitudinal fracture of its base, as its eastern third is clearly outside the unified line of the first two thirds.

The upper parts of the piles of all the modules (which were in the water) were covered with algae, indicating a certain friendliness of the glass-basalt-plastic to biota and its ability to form the basis of an underwater reef. If the lower part of the piles was free of vegetation, this meant that it had been covered by sand during the growing season up to the time of the survey. During the resurvey on 12.04.2023, an increase in the lower bare part of all modules was recorded, indicating that sand had been partially washed away from the underwater slope.

Fig. 4. State of the “Grebenka” breakwater modules: *a* – algae fouling and tilt of the structure (survey on 7 September 2022); *b* – post-storm partial exposure of the wave-damping piles from under sand (survey on April 12, 2023)

The preparation of the breakwater site is important for the safety of structures exposed to wave action. Initially it was assumed that no bottom preparation would be required. However, the influence of coastal currents in the vicinity of the underwater berm in the absence of bottom preparation resulted in the breakwater subsidence into the sand.

Some of the modules changed their position after the experiment, which means that despite the use of concrete to weight the structure, the effects of the waves and currents were sufficient to shear the structures. One solution to this problem is to weight the structure or, as discussed above, to prepare the bottom more thoroughly.

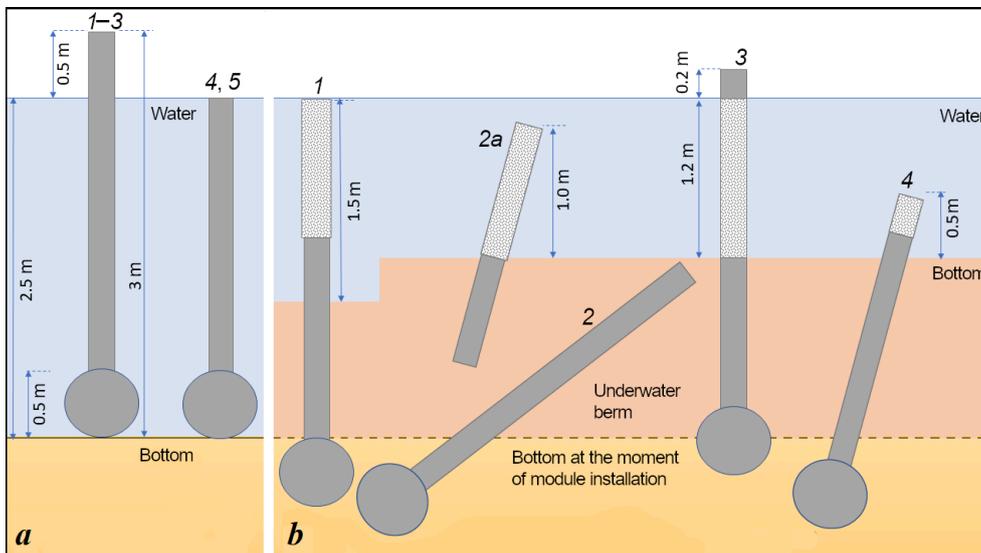
Fig. 5. Schematic initial position of the modules (1–5) during installation in May 2021 (*a*) and their final position during the survey on 07.09.2022 (*b*). The parts fouled with algae are highlighted in light gray. The diagram shows the subsidence of modules and their sanding up, deviations from the vertical axis, and changes in the height of the surface part
