Testing of a Piled (Permeable) Breakwater Made of Composite Materials for Coastal Protection. Part 2. Evaluation of Impact on the Shore State

The paper analyzes the effectiveness of a pile breakwater structure *Grebenka* for coastal protection purposes. From 03.10.2020 to 30.04.2023, full-scale testing of the structure was conducted on the northern shore of the Kaliningrad Oblast near the city of Zelenogradsk between the eroded and accumulative shore segments. Four breakwater modules were installed in a single line in the groin pocket at a depth of about 2 m offshore of the groin end but did not completely overlap the pocket. One module was installed in the immediate vicinity of the shoreline. The experiment covered several seasons of severe storms, which allowed us to compare the shoreline dynamics at the breakwater installation site and in the neighbouring areas. We carried out regular measurements of the beach width, aerial survey, repeated depth measurement at the installation site and assessed the underwater slope dynamics. We also determined the thickness of the sand cover layer at the structure installation site and placed tilting flow velocity sensors on the breakwater. It

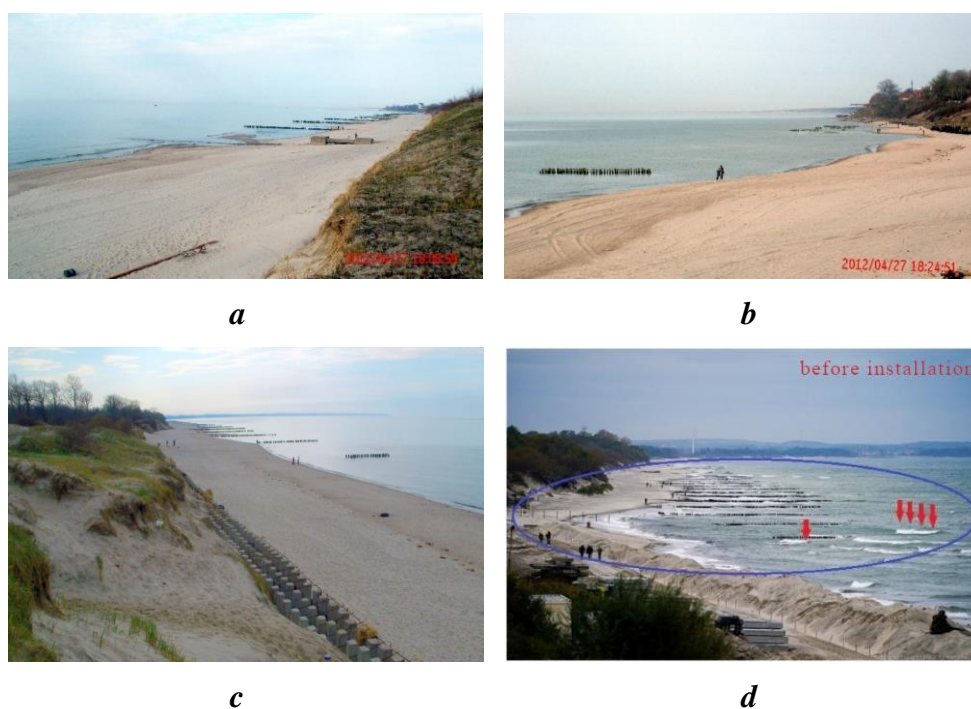
Fig. 2. State of the beach: *a* – stable beach at the western tip of the old groins site (the early 20th cent.) (27.04.2012); *b* – lee erosion at the eastern tip of the old groins site (27.04.2012); *c* – seasonal beach restoration identified by a strip of washed sand, including in the shady zone of the groins (27.04.2012) (photo by A. N. Babakov); *d* – the state before the period of autumn-winter storms in 2020, 19.10.2020. The arrows indicate the future position of the breakwater modules

Only after the construction of a new group of groins in early 2017, the beach in the previously erosion-prone urban section recovered quickly. However, in the 700 m interval between the groups of old and modern groins, the beach is actively eroded by storm events (Fig. 2, *d*).

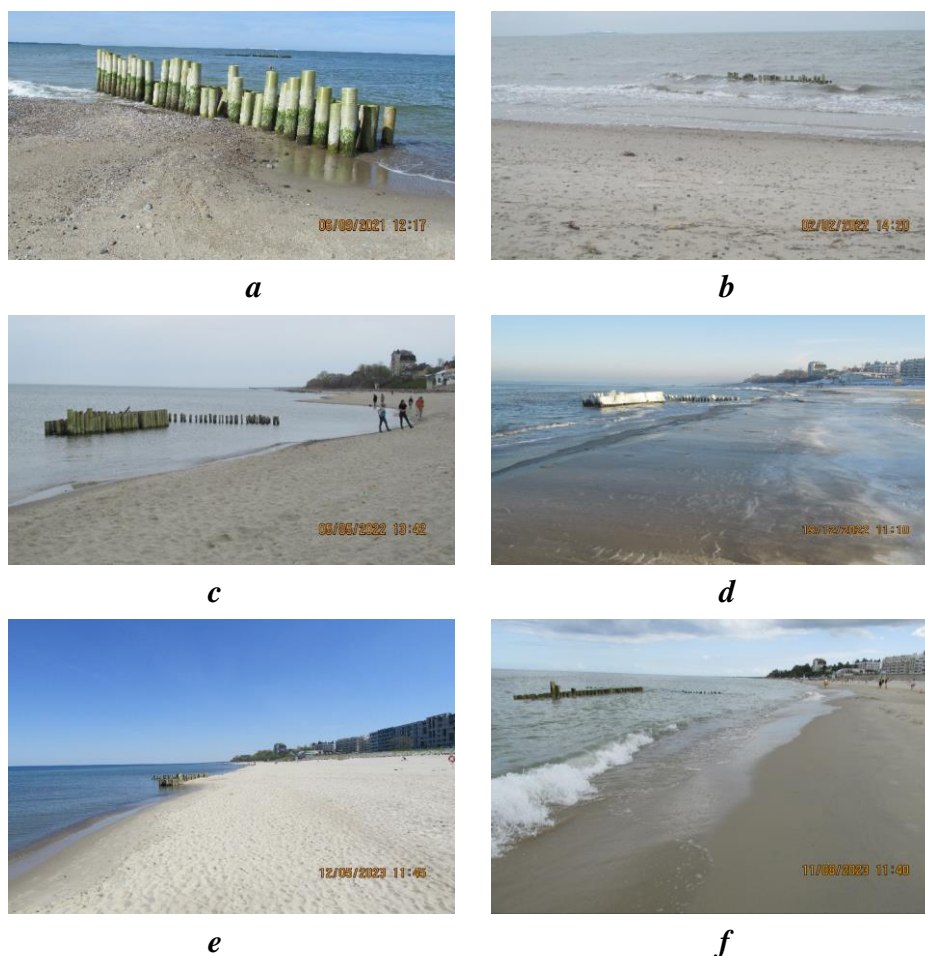
Fig. 4. The beach dynamics after the installation of the breakwaters in 2021–2023: *a* – summer accumulation, 06.09.2021; *b* – beach narrowing after extreme storms, 02.02.2022; *c* – the state of the beach after the storm period, 05.05.2022; *d* – beach nourishment in the finishing phase of the winter storm, 19.12.2022; *e* – the beach restored by moderate spring waves, 12.05.2023; *f* – beach narrowing due to a noticeable increase in the sea level, 11.08.2023. Photo by A.N. Babakov

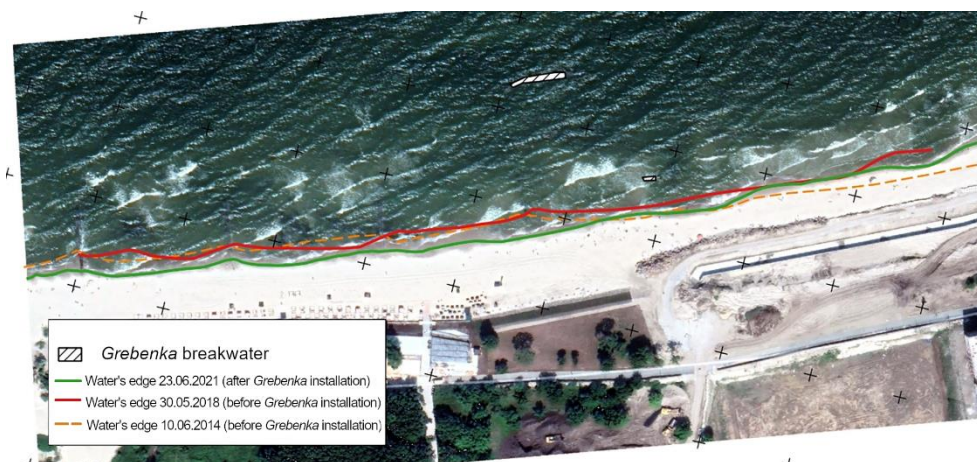
Fig. 6. Interannual dynamics of the water's edge near the breakwater before and after its installation (2014 – GoogleEarth source, 2018 – satellite image ResursP, 2021 – GPS tracing)

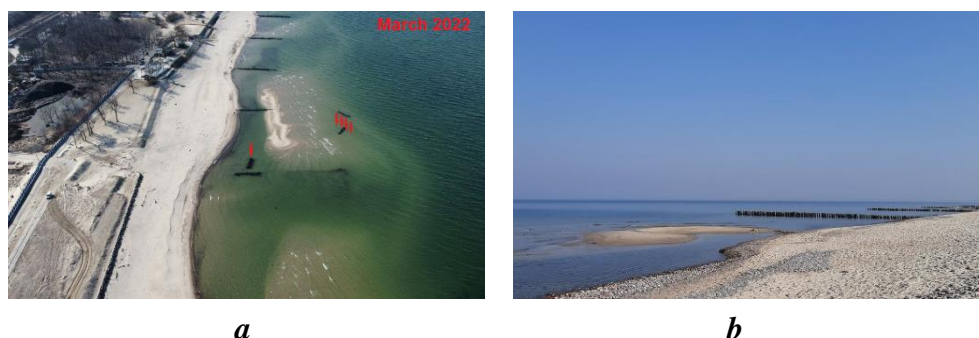
Fig. 12. Exposure of the top of the underwater alongshore bar in March 2022 shortly before its attachment to the water's edge at an extremely low sea level: *a* – the shore segment where the breakwater was installed (red arrows); *b* – the shore segment 400 m west of the breakwater installation site
